# Arvin & Associates

## Professional Building Inspection

## HOME INSPECTION REPORT

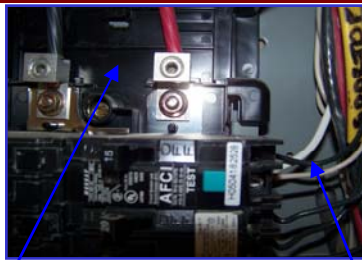
**No Main breaker exist at sub panel**

**No main breaker/Whitewire feed into breaker**

Recommend a Licensed Electrician evaluate further for any needed repairs or replacements

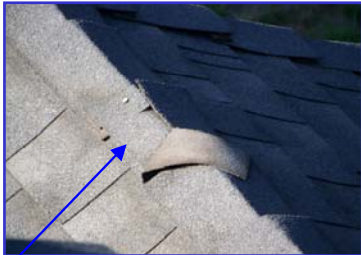
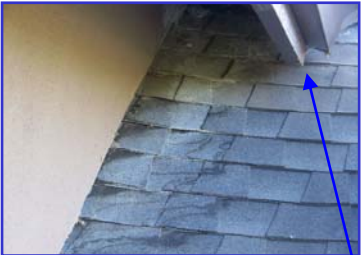
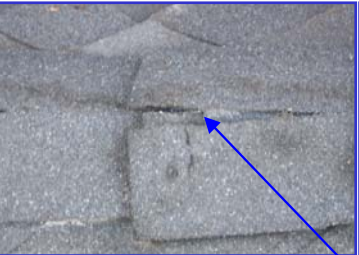
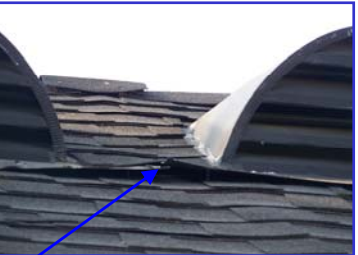
Lifted composition @ front Left side	Evidence of water stain/ over master bed room	Evidence ridge deterioration over Master bed room	uplifting at rear high roof
	<u>See gutter &amp; down spouts for furthe recommendations</u>

**1-Evidenc eof conditions in need of corrections exist at roof  
Recommend further roof evaluation & correction by a licensed roofer**

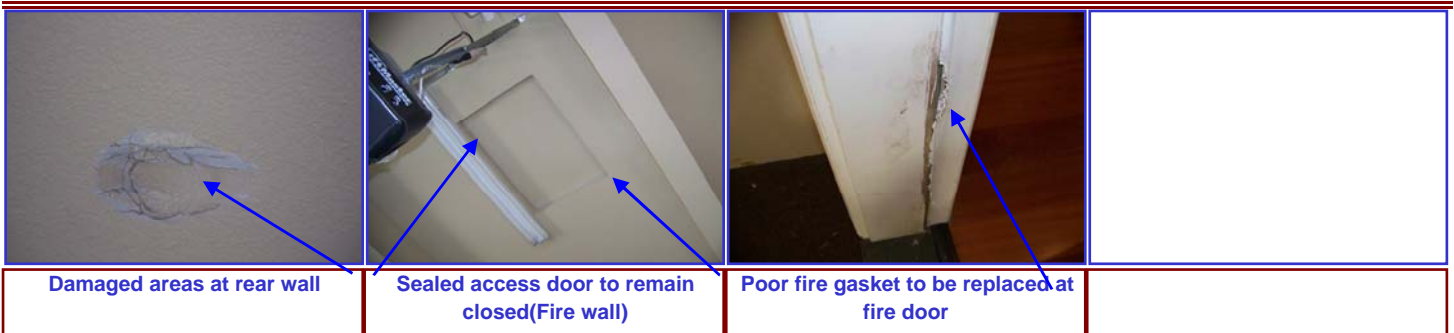
- 1- Evidence of damaged areas exist at back wall (recommend guard posts to prevent future conditions)
- 2- Access above ceiling does not comply w/ fire wall requirements if it is opened .
- 3- No cabinet top exist at left side cabinets
- 4- Evidence of poor fire gasket exist at fire door

Damaged areas at rear wall

Sealed access door to remain closed(Fire wall)

Poor fire gasket to be replaced at fire door

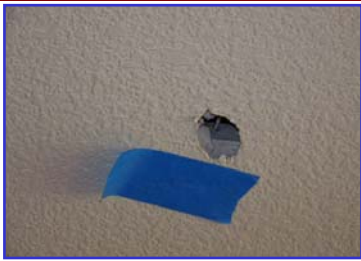
<b>Hole at ceiling</b>

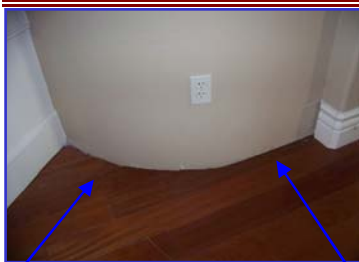
See Notes at Living Room       Normal settling cracks noted  
**Wall Finish:** Good      **Type:** Paint  
**Flooring:** Good      **Type:** Wood  
**Window(s):** Good      **Type:** Fixed      **Screens:** N/A  
**Door(s):** Good      **Type:** Single      **Screens:** N/A  
**Closets/Cabinets:** Good  
**Ceiling Light:** Functioning      **Ceiling Fan:** Not Installed  
**Remarks:**  Unable to check all electrical outlets (in-use or not accessible)  
**1-Evidence of missing baseboard molding exist at curved wall next to stair**

Missing base board at entry

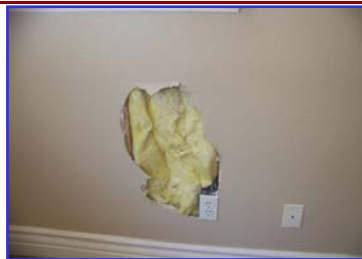
- 1- window needs adjustment(Call MFR. For correction)
- 2- Evidence of damaged exist at wall

Damaged area at wall

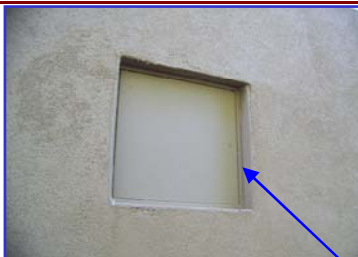
2- No access to equip.under tub to verify Electrical GFCI condition(recommend verifying installed GFCI outlet)

Access door under tub.could not be opened

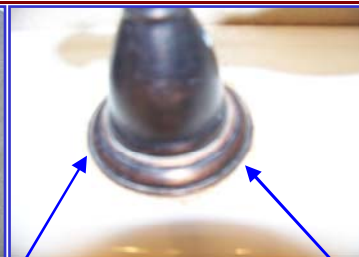
Evidence of previous leak around faucet@ right sink

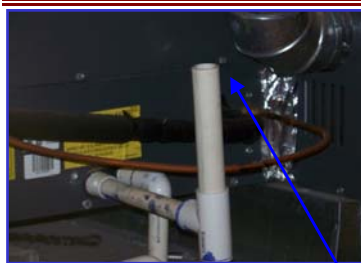
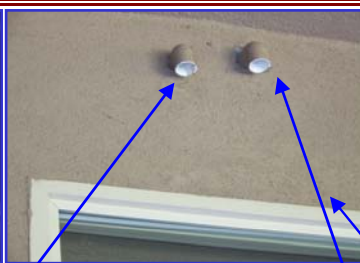
- 1- Evidence of no cap over PVC drain pipes exist in the attic at HVAC units
  - 2- Cooling is not proper(In need of maintenance service )
- (Recommend further evaluation & correction by a licensed HVAC Tech.)

Missing cap over PVC drain pipes

Condensation drains not extended to lower side

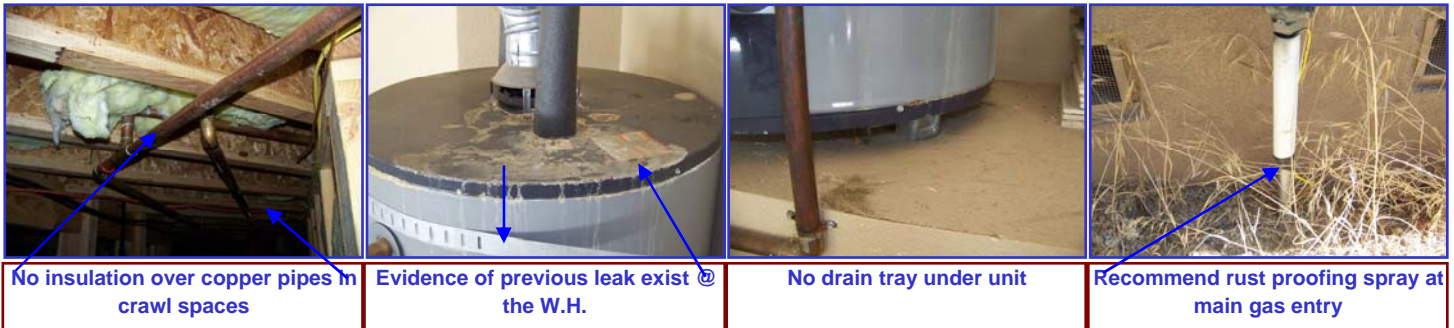
**1- Toilet flushing is not working proper/ Loose valve (in first floor 1/2 bath)**  
**2-Dishwasher is not working(Not Draining)**  
**3-Ceiling shower is not working in master bath room (Faucet valves are missing)**  
**4-No insulation over copper pipes in crawl space(Recommend installing insulation over exterior&copper pipes))  
 Recommend evaluation&correction of all the above conditions by a licensed plumber**

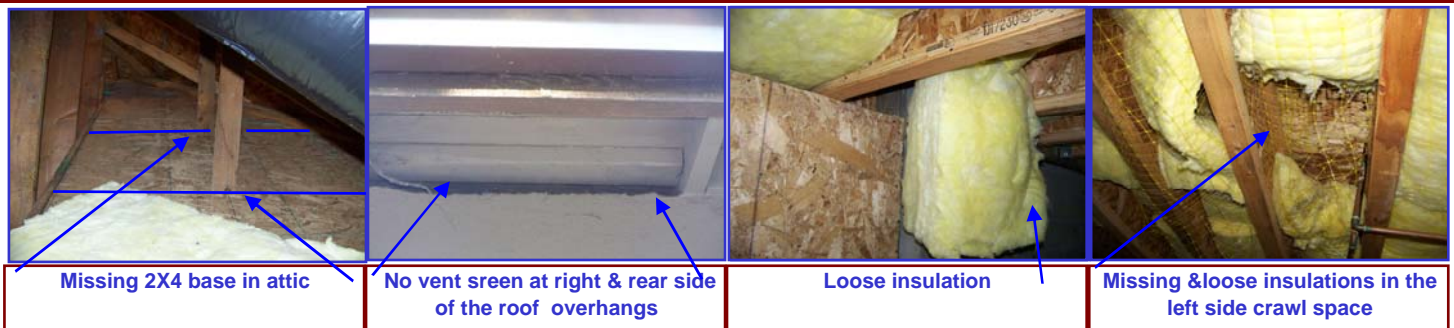
1-Evidence of missing & loose insulation exist @ the crawl space located on the left side(Under master bed room)
